THE MIAMI CONSERVANCY BULLETIN

DECEMBER, 1923

Review of the Work at Hamilton

Local Improvement at Southern End of the District Completed in 1923.

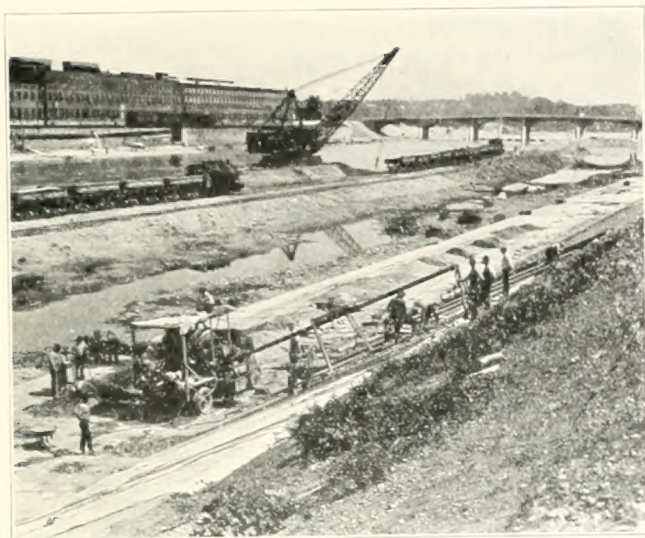
FIG. 402.—CONSTRUCTION ACTIVITIES AT HAMILTON.

In the foreground is the concrete mixer pouring slope revetment two slabs high, each slab being 13.5-ft. on the slope. In the center is a dragline loading cars. At the right is the Black St. bridge.
